**Flood Control Project Maintenance
Levee Inspections
LMA District Cover Sheet
Spring 2010 Levee Inspection Results**

Reclamation District No. 2063 Crows Landing

Levee Inspection Report By Mile - Spring 2010

Waterway						Bank	Unit Miles	Inspection Start/End	Inspector	
Unit No. 01 San Joaquin River						Right	10.63	05/17/2010 05/17/2010	Richard Willoughby	
LMR No	Levee Mile		Category	Item	Location	Rating	Action/Comment	GPS Latitude/Longitude		Issue No. Photo
	Start	End						Start	End	
1	0.00	10.63	Earthen Levee	Vegetation	LS	M	Control annual grass and weeds on the levee slopes and easements.	37.478860 ° -121.044640 °	37.390464 ° -121.941192 °	2
2	0.00	10.63	Earthen Levee	Vegetation	WS	M	Control annual grass and weeds on the levee slopes and easements.	37.478860 ° -121.044648 °	37.390464 ° -121.941192 °	3
3	1.19	1.19	Earthen Levee	Animal Control	LS	A	Exterminate rodents and backfill and compact or grout burrows.	37.465688 ° -121.034907 °	37.465688 ° -121.034907 °	969
4	1.33	1.33	Earthen Levee	Animal Control	LS	A	No rodents visible, but rodent burrows visible; need to backfill and compact or grout borrows.	37.464643 ° -121.032930 °	37.464643 ° -121.032930 °	970

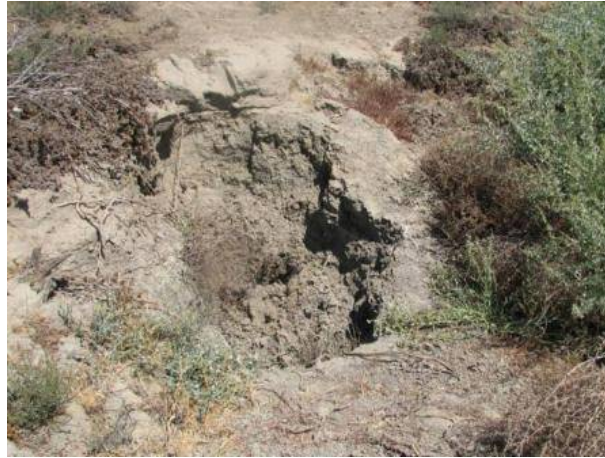
SJR2009_RM105.5a.JPG

Levee Mile Report Line	16
Start Levee Mile	2.72
End Levee Mile	2.72
Location	Water Side
Category	Supplemental
Item	DWR Erosion Survey

2009: Note this site has not been reported to be repaired [2009 SiteID:RD2063U1RM105.5]

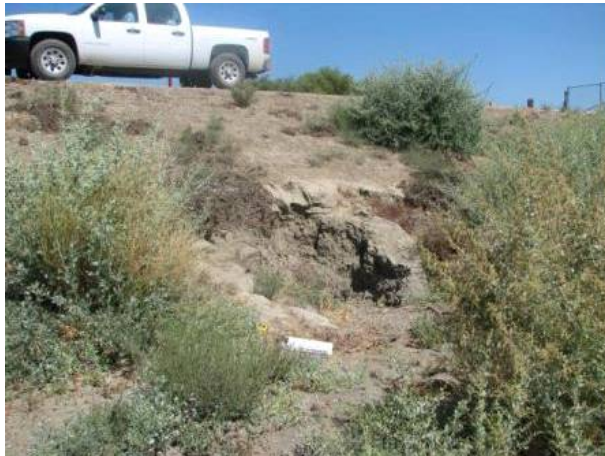
SJR2009_RM105.5b.JPG

Levee Mile Report Line	16
Start Levee Mile	2.72
End Levee Mile	2.72
Location	Water Side
Category	Supplemental
Item	DWR Erosion Survey

2009: Note this site has not been reported to be repaired [2009 SiteID:RD2063U1RM105.5]

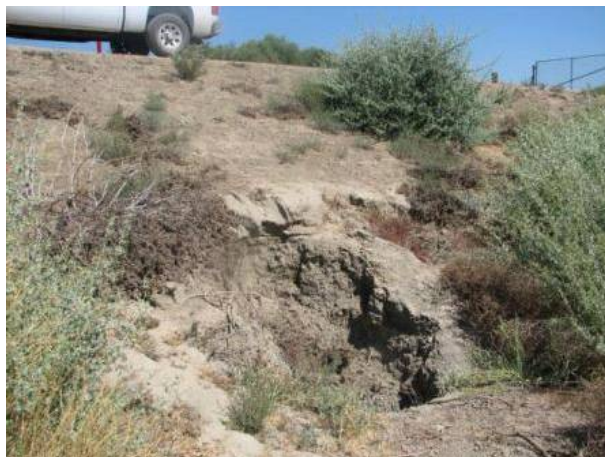
SJR2009_RM105.5c.JPG

Levee Mile Report Line	16
Start Levee Mile	2.72
End Levee Mile	2.72
Location	Water Side
Category	Supplemental
Item	DWR Erosion Survey

2009: Note this site has not been reported to be repaired [2009 SiteID:RD2063U1RM105.5]

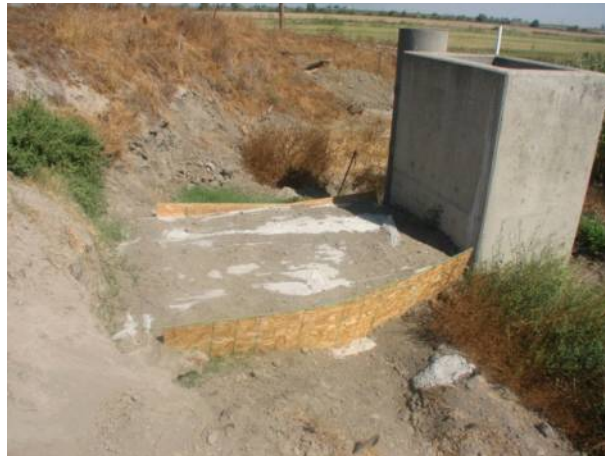
richard_s_20100505_065.jpg

Levee Mile Report Line	28
Start Levee Mile	5.13
End Levee Mile	5.13
Location	Land Side
Category	Earthen Levee
Item	Encroachments

View of concrete stand pipe and encased pipe on landside toe.
